MISCELLANEOUS PAPER CERC-85-9

SIDE-SCAN SONAR OF BAILEY'S DAM, RED RIVER, ALEXANDRIA, LOUISIANA

Joan Pope

September 1985

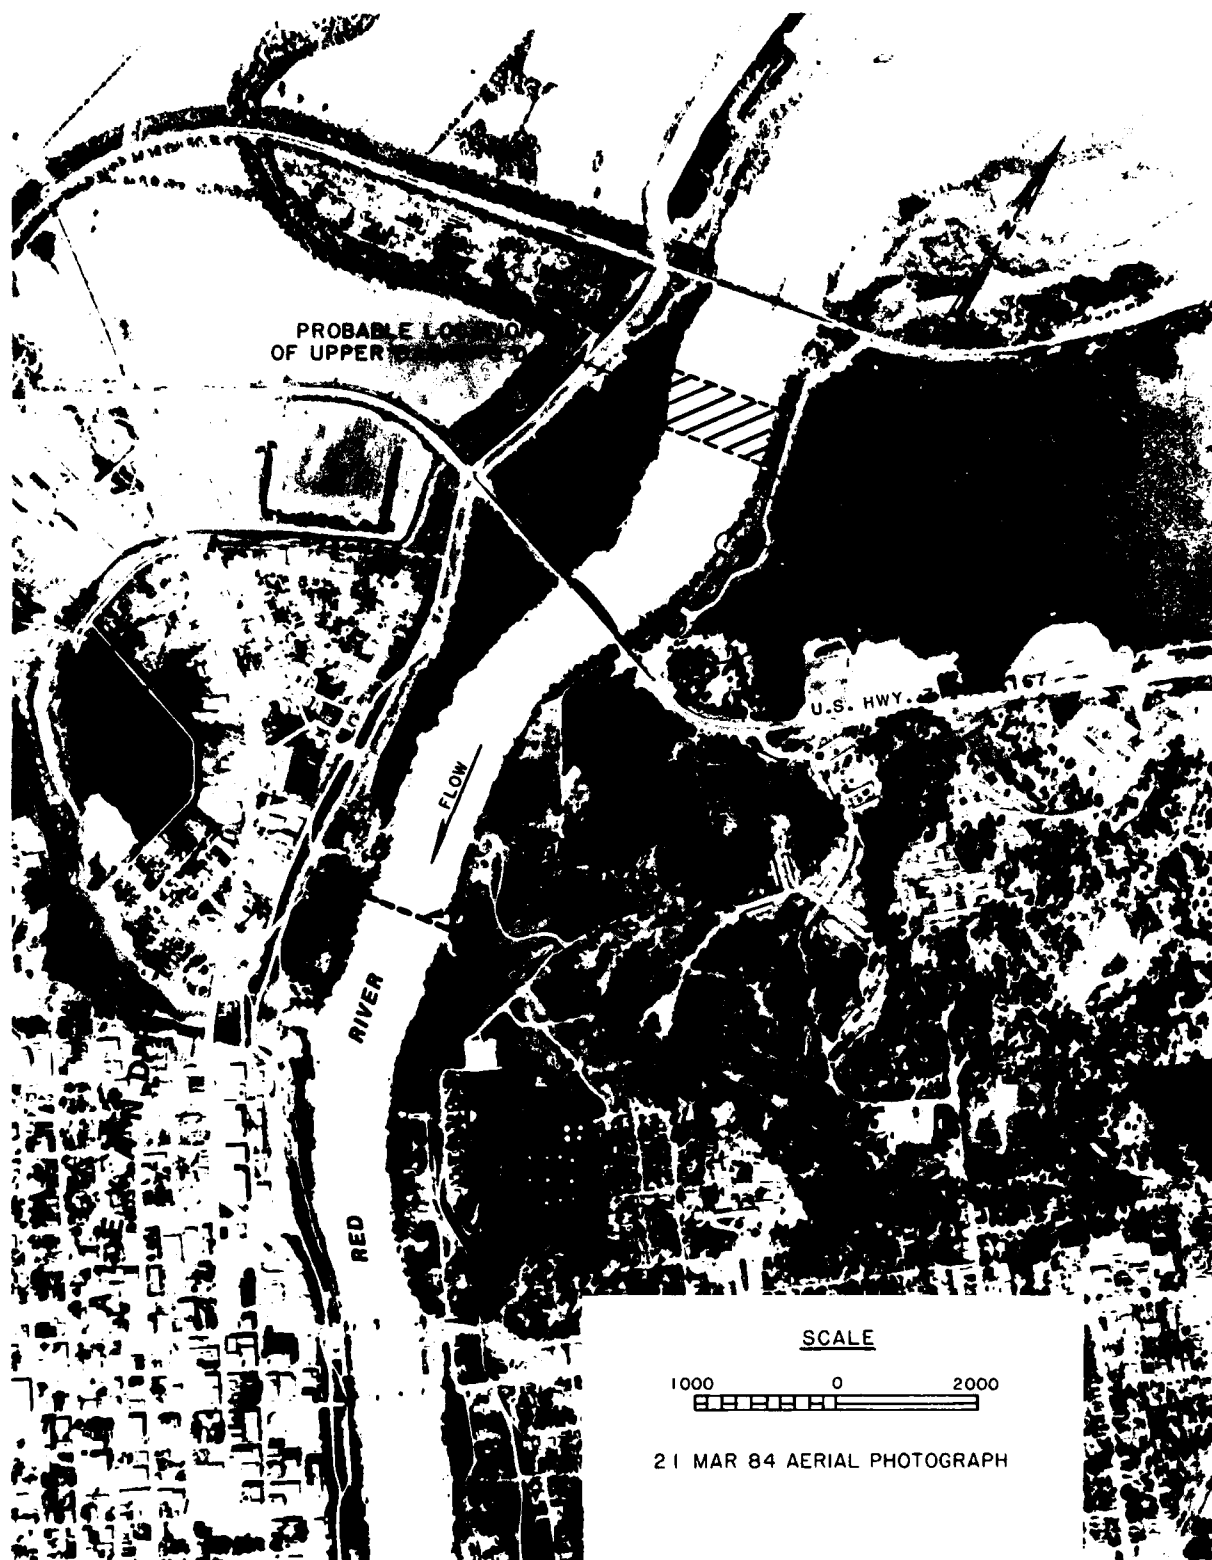
Figure 4. 21 Mar 84 aerial photograph

6. A series of runs was conducted from the Highways 71, 165, 167 Bridge under the Missouri-Pacific railroad bridge, to the new boat launching ramp just downstream of Bayou Rigoleta. As a result of this survey reasonable location for Upper Bailey's Dam has been identified. The survey continued to identify a cross-channel lineation or masking and even the suggestion of crib-like features in the midchannel area at a location approximately midway between the first and second reference poles downstream of the railroad bridge, labeled "C" and "D" in Figure 4 and the example sonographs (Figures 10-13).
